PRELIMINARY ASSESSMENT/ REMOVAL SITE EVALUTAIION REPORT

Mexico FMGP Site
Audrain County, Missouri

September 15, 2000

Missouri Department of Natural Resources
Division of Environmental Quality
Hazardous Waste Program

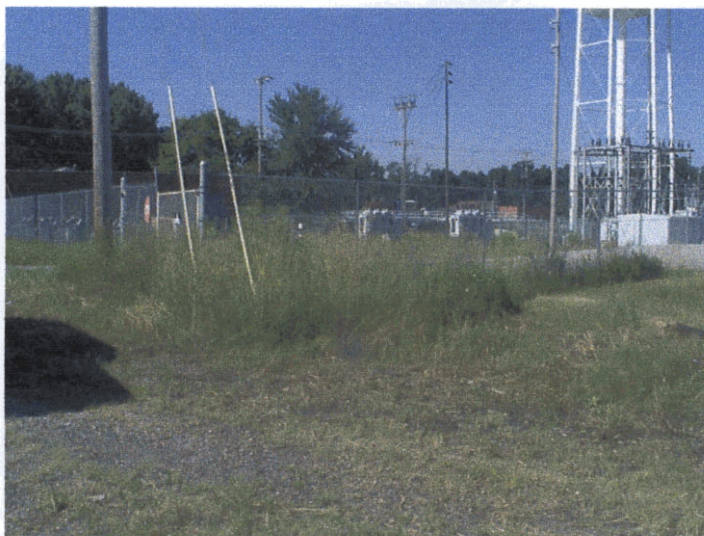
Photo 1. Mexico FMGP. View of site area taken northeast of the northeast corner of the fenced area. This area contains a small area of darkly stained surface soil. Taken by Kimberlee Foster, HWP, DNR on 7/14/2000 facing southwest.

Mr. Allen and I then investigated the area to the northeast of the northeast corner of the Ameren UE fencing. This area was identified as the former coal storage area, with dark surface soil staining, during the SS investigation. Mr. Allen and I identified the area of stained soil approximately 10 feet to the northeast of the northeast corner of the fence, approximately 160 feet south of the railroad tracks. This area is currently covered by areas of lush, green vegetation (see photographs 1 and 3). In addition, there is a small debris pile to the north of the site area that contains railroad ties and various patches of vegetation (see photograph 2).

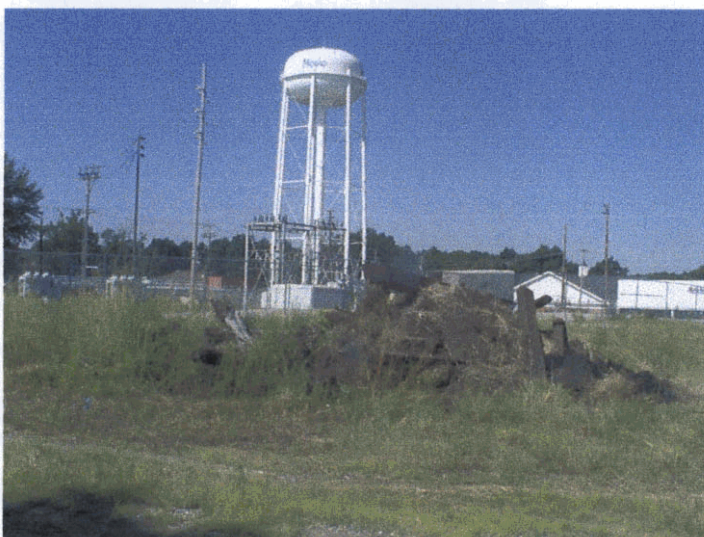
Photo 2. Mexico FMGP. Debris pile located northeast of the site area, approximately 100 feet south of the railroad tracks. Taken by Kimberlee Foster, HWP, DNR on 7/14/2000 facing southwest.

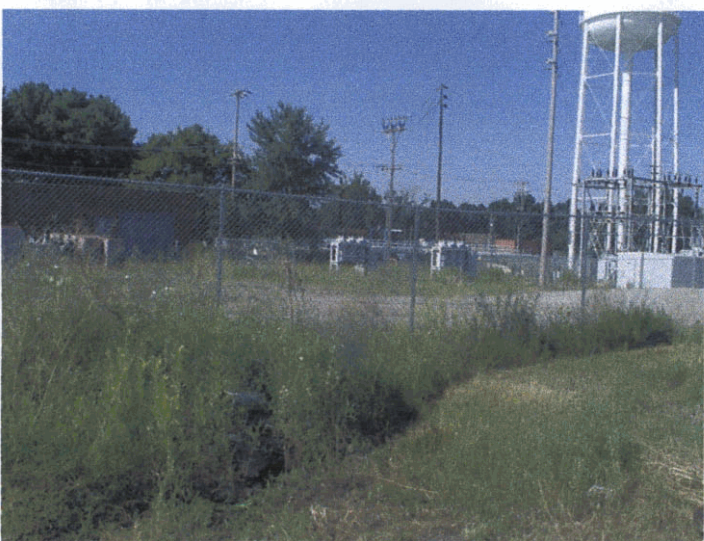
Photo 3. Mexico FMGP. View of site area taken northeast of the northeast corner of the fenced area. The area of darkly stained surface soil is beneath the vegetation. Taken by Kimberlee Foster, HWP, DNR on 7/14/2000 facing southwest.

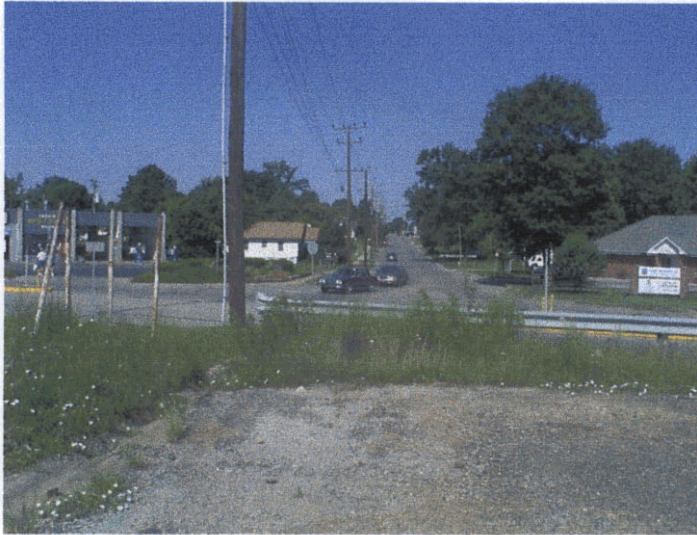
Photo 4. Mexico FMGP. View of former section of Liberty Street at its intersection with Muldrow Street, located to the west of the site area. Taken by Kimberlee Foster, HWP, DNR on 7/14/2000 facing west.

To the west of the site is a paved area identified during the SS investigation as being a "driveway with tar-like staining". During the SS, the ownership of the paved area was in question and no samples could be collected. After several conversations with the city of Mexico engineers, I determined that this area was the remains of a former paved street known as Liberty. Liberty Street formerly began at its intersection with South Western Street (to the northwest of the site area) and extended west across and beyond Muldrow Street. The small section of Liberty Street, to the east of Muldrow Street, was closed when an underpass for the nearby railroad was built for Muldrow Street. At that time, the small section (less than one block) of Liberty street that remained to the east of Muldrow Street was abandoned and a guardrail was placed at its intersection with Muldrow Street (see file photograph 4). Mr. Allen and I carefully

inspected the remains of the former street for evidence of "tar-like staining" and found nothing more than what appears to be old, decaying asphalt from the former road's surface.

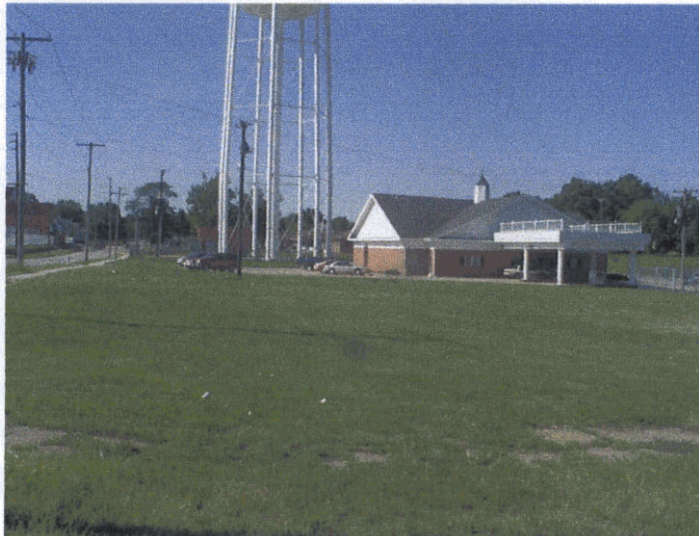
Photo 5. Mexico FMGP. View of grassy area and bank located south of the former Liberty Street and west of the site area. Taken by Kimberlee Foster, HWP, DNR on 7/14/2000 facing south.

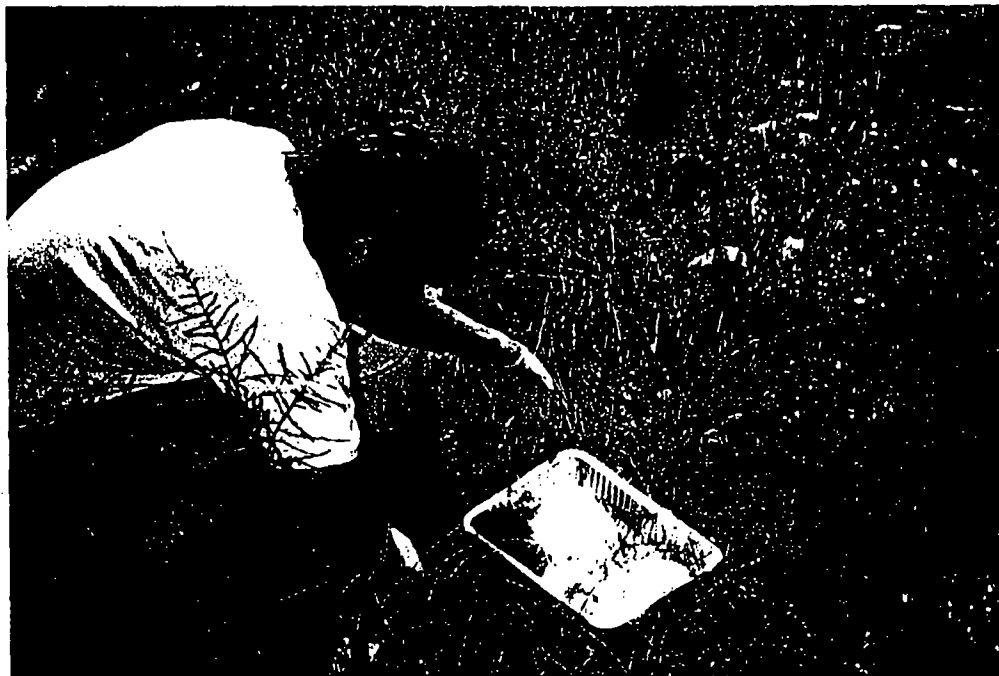
Photo #3 Close-up view of ESP personnel collecting a surface soil grab at location "SB-1".

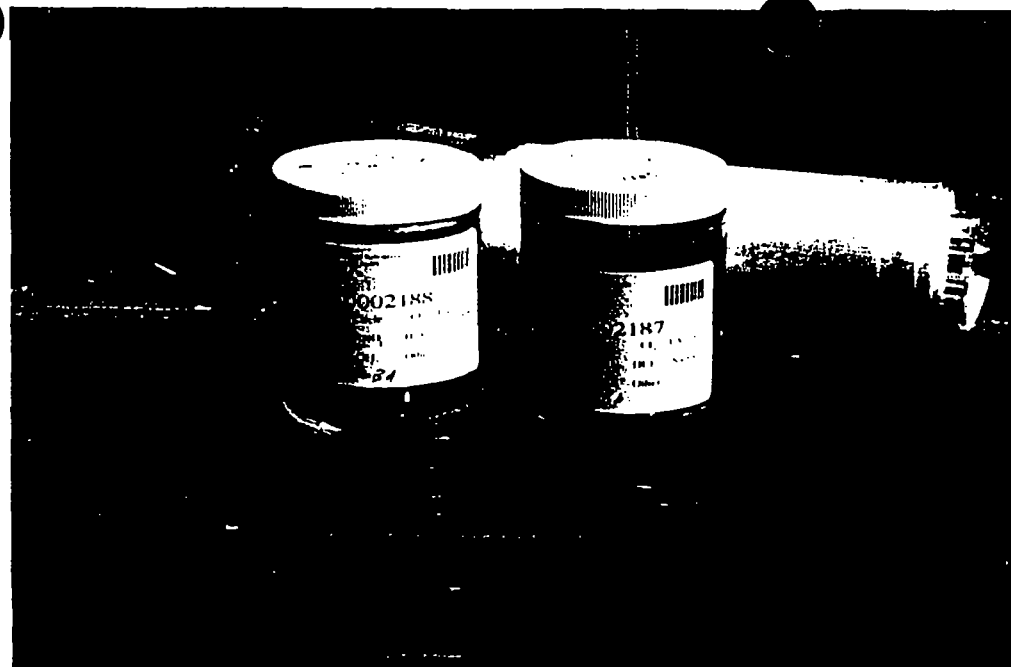
Photo #5 Close-up view of samples 0002187 and 0002188 immediately after collection.

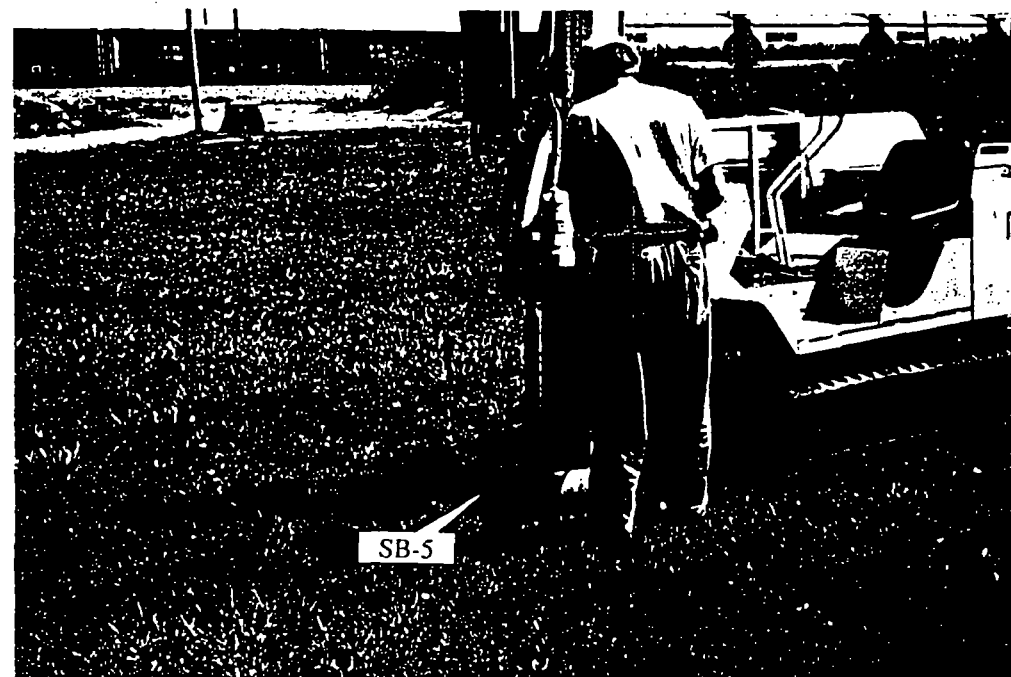
Photo #6 View looking north-northeast of ESP personnel conducting soil boring at "SB-5".

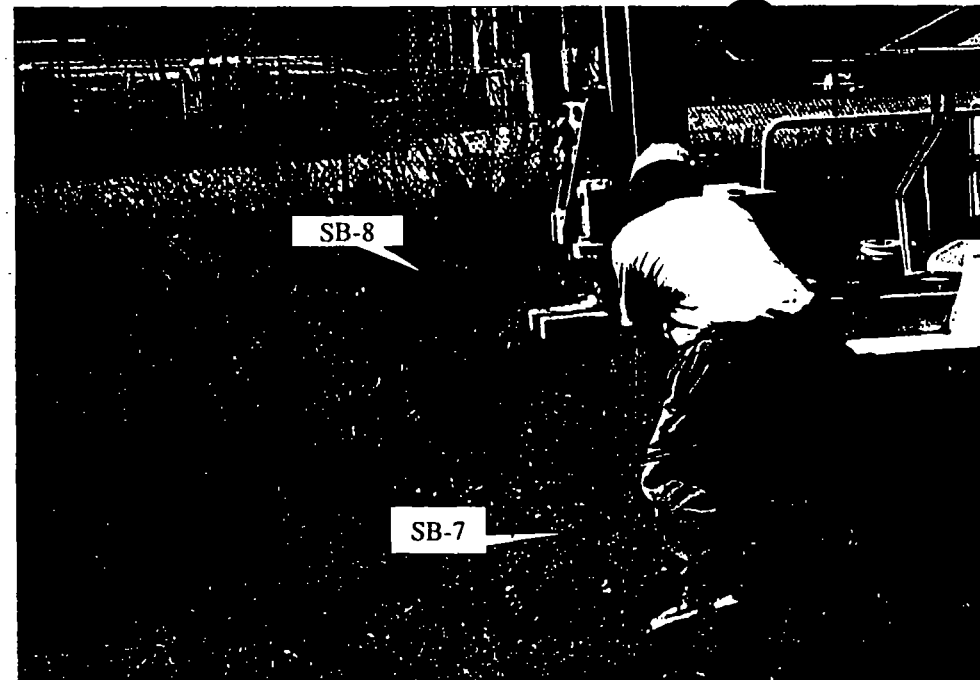
Photo #8 View looking south-southwest of ESP personnel retrieving soil from location "SB-7". Location "SB-8" is in the background.

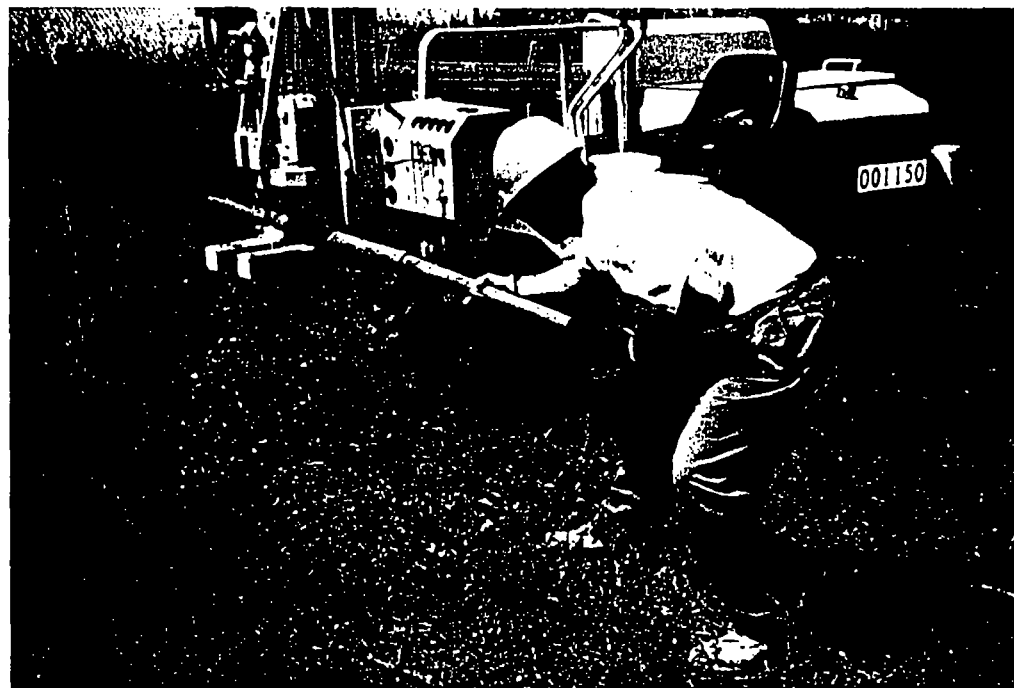
Photo #9 View looking west of ESP personnel retrieving soil from location "SB-8".
